# 3× THE SERVICE LIFE ON A FAILING LNG CRYOGENIC BALL VALVE

A main ship-to-shore isolation valve was leaking every three months and taking half a year to repair overseas. Anthis found the design flaw the original manufacturer missed, re-engineered it, and returned zero-leakage performance, delivered locally in under a month.

Anthis Valve Enterprises, Inc. | Houston, TX  
Customer identity withheld under NDA. Referenced throughout as a major Gulf Coast LNG export terminal.

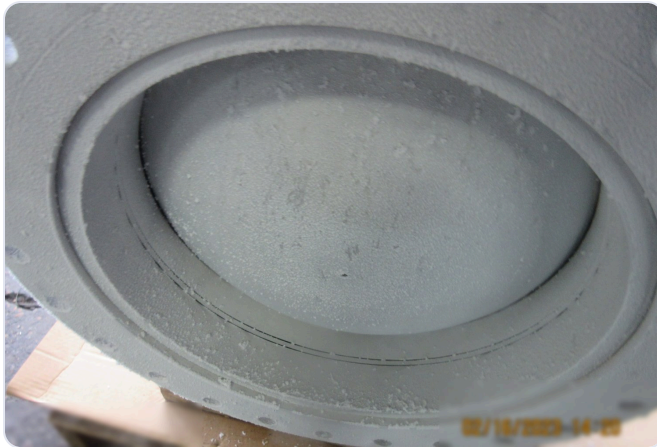
Anthis stripped and inspected two of the units. The failure was not wear from age. It was built into the seat design: the pre-load structure could not hold sealing force through repeated ambient-to-cryogenic cycling.

The seat and body materials contract at different rates, so at  $-161.5^{\circ}\text{C}$  the sealing face was loaded unevenly.

The seat's elastic recovery faded after repeated open-and-close cycles, so it stopped pushing back against the ball.

Less spring-back meant less sealing force, which drove wear on the sealing face and, finally, external leakage.

Inspection of the sealing face during teardown.

We recalculated the seat contact pressure and rebuilt the Belleville (disc) spring compensation so the seat holds constant sealing force as the valve moves between ambient and cryogenic temperature.

We moved to high-performance modified PTFE and UHMWPE seats, better suited to Houston humidity and repeated cryogenic cycling than the original materials.

We reworked the ball-to-seat lapping to a strict zero-leakage standard, verified on test before the valve left the shop.

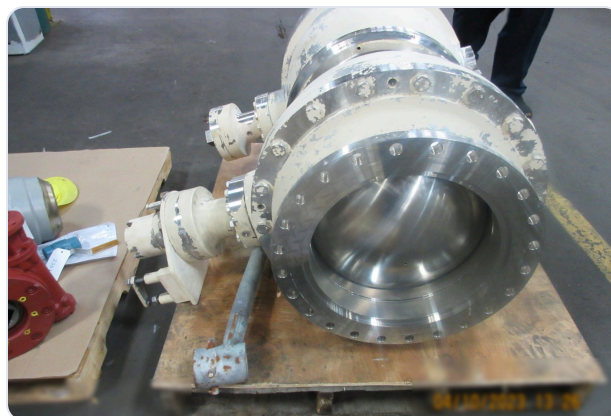
*The rebuilt cryogenic valve, bore and seat finished to a zero-leakage standard.*

☉ Cryogenic bonnet work per **MSS SP-134** and **BS 6364**. Bonnet welding by **ASME-qualified welders** on impact-tested procedures. Final leakage verified by **helium testing**.

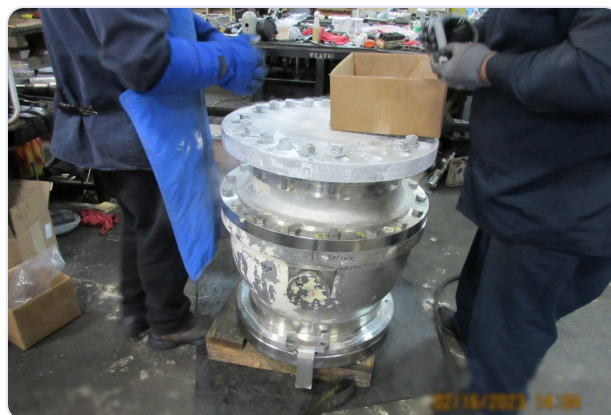
*Reassembly and fit-up in the Anthis shop.*
