# 2-3× THE SERVICE LIFE ON A FAILING LNG CRYOGENIC BALL VALVE

A main ship-to-shore isolation valve was leaking every three months and taking half a year to repair overseas. Anthis found the design flaw the original manufacturer missed, re-engineered it to last far longer, delivered locally in under a month.

## EXECUTIVE SUMMARY THE BOTTOM LINE

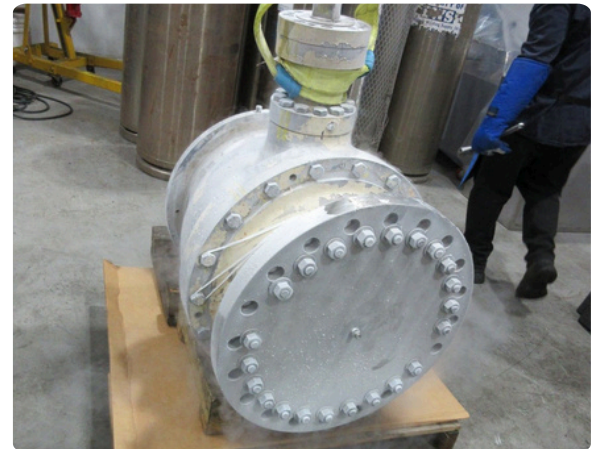
Cryogenic valve work in the Anthis shop, staged beside cryogenic test dewars.

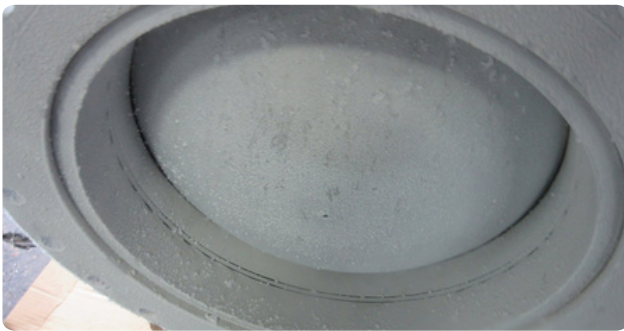
Anthis stripped and inspected two units. The failure was not wear from age. It was built into the seat design, which could not hold sealing force through repeated ambient-to-cryogenic cycling.

Inspection of the sealing face during teardown.

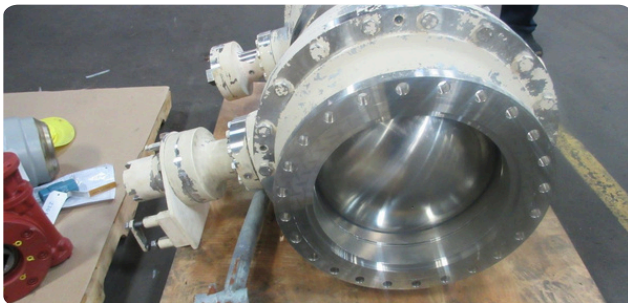
The rebuilt valve, bore and seat re-engineered and finished to a tight tolerance.

The original manufacturer rebuilds to the same drawing, flaws included. And they re-engineered this seat to hold a constant seal across the full temperature range.

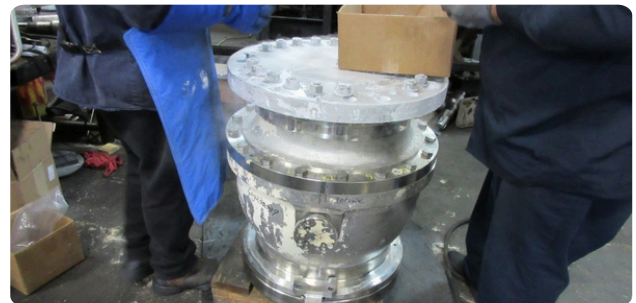
Reassembly and fit-up in the Anthis shop.
